Coatings For Industry, Inc.

Homestead High-Level Bridge

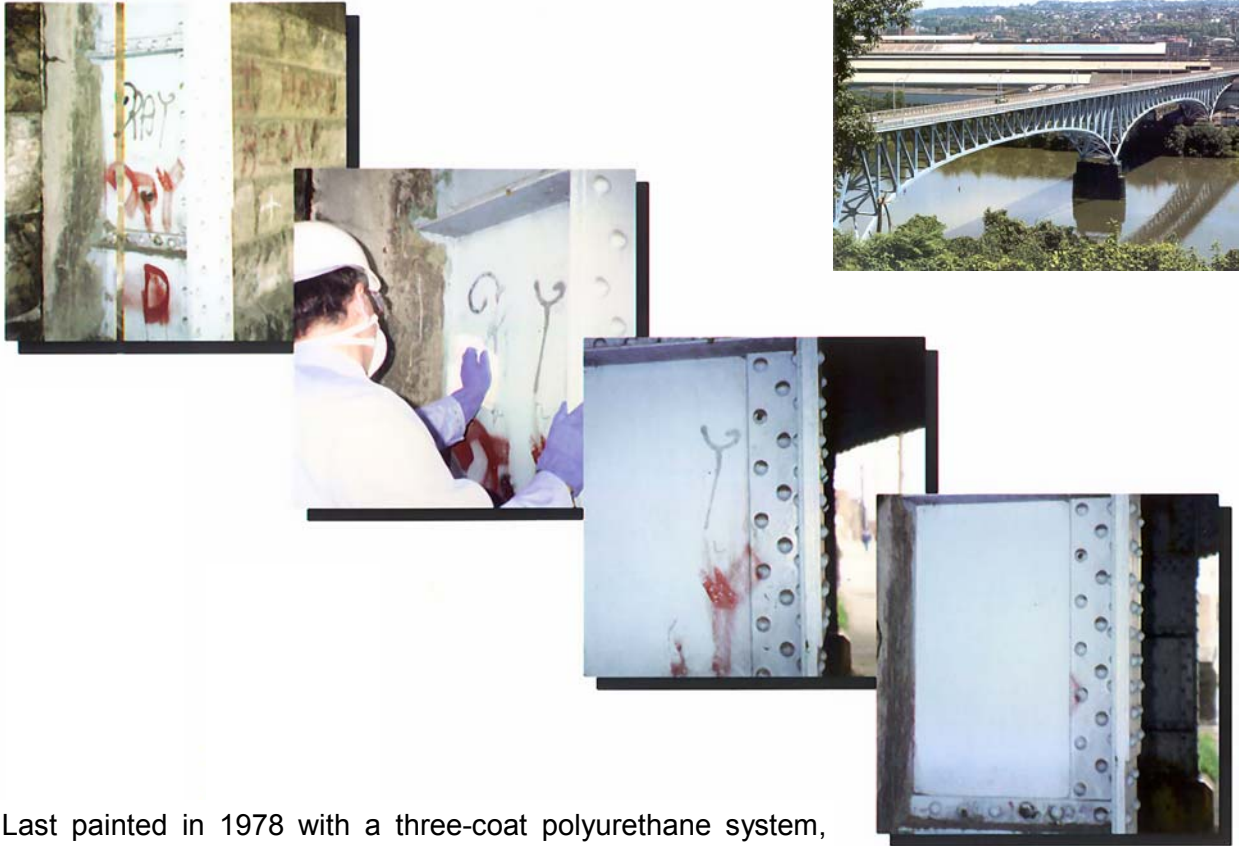
Last painted in 1978 with a three-coat polyurethane system, the Homestead high-Level Bridge near Pittsburgh has a steel column near a sidewalk. Over the years, vandals have found its proximity irresistible, defacing the light blue topcoated column with red and black spray-painted markings.

Although some of the graffiti was on the column “for at least 10 years,” a recent cleaning using MEK and toluene “easily removed the dirty work with no damage to the 15-year old coating system,” said Richard Connors, Director of Public Works for Allegheny County. “Even after all this time, the polyurethane topcoat looked almost new after the cleaning.”

The three-coat system, supplied by **Coatings For Industry, Inc.**, of Souderton, PA, includes a moisture-curing aluminum spot primer and intermediate coats containing **Bayer’s** Desmodur aromatic polyisocyanates. The final finish is a polyurethane topcoat incorporating Desmodur aliphatic polyisocyanates and Desmophen polyester polyols from **Bayer**.
